General Summary

Hudson FL 34667

10. Seawall Inspection

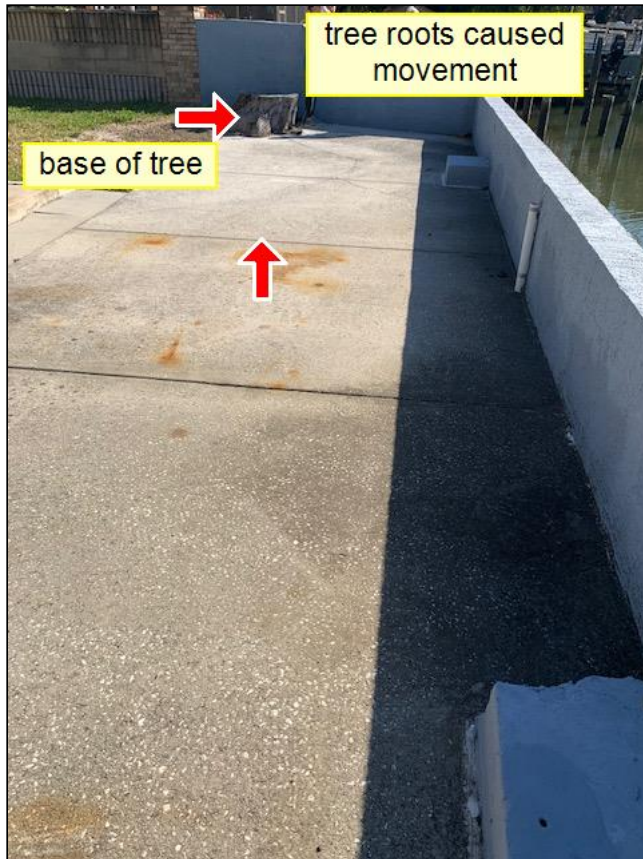
10.0 Item 1(Picture)

The seawall cap had many cracks along the length of the wall. These can be filled with an epoxy

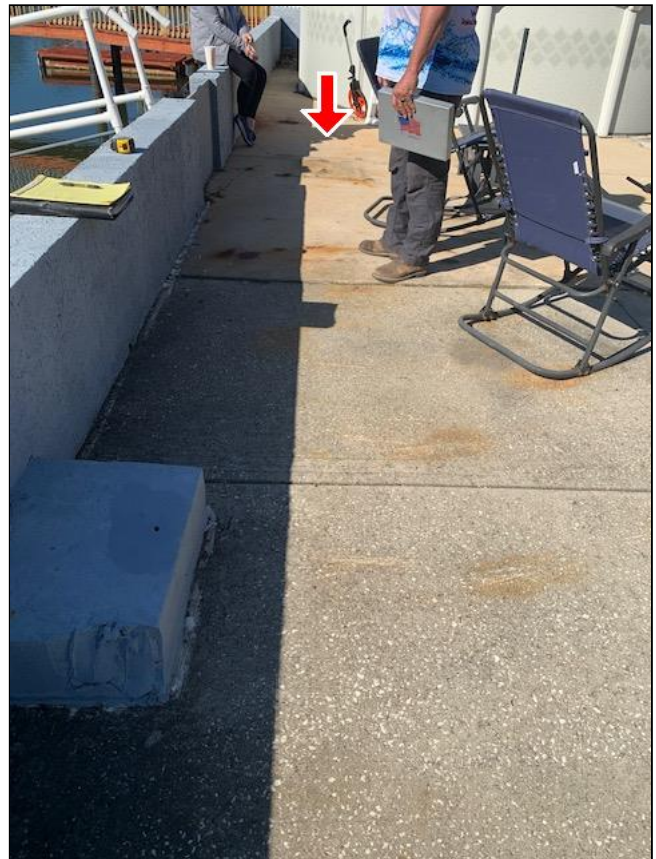
10.0 Item 2(Picture) cracks in pool area

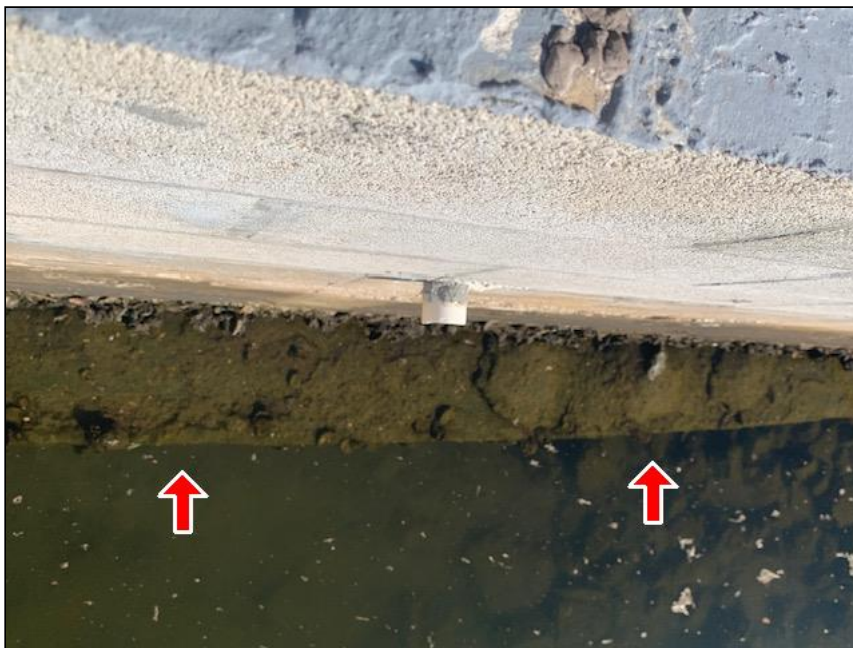
The footer is being undermined at approximately 45LF across the length of wall. This condition allows the wall and cap to settle downward.

10.1 Item 1(Picture) footer undermined west corner out 15ft

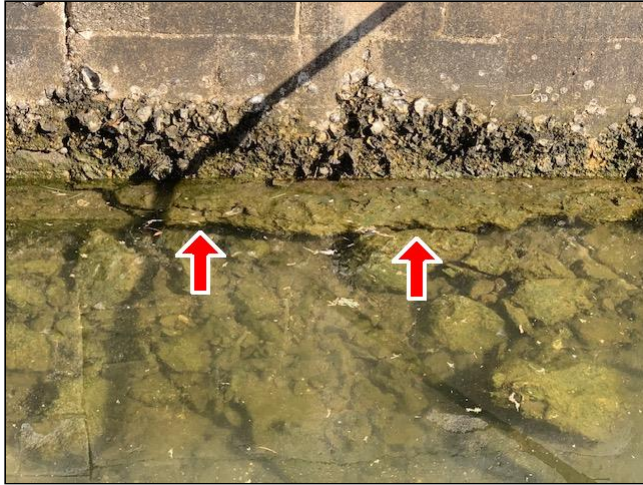
10.1 Item 2(Picture) washout visible under footer

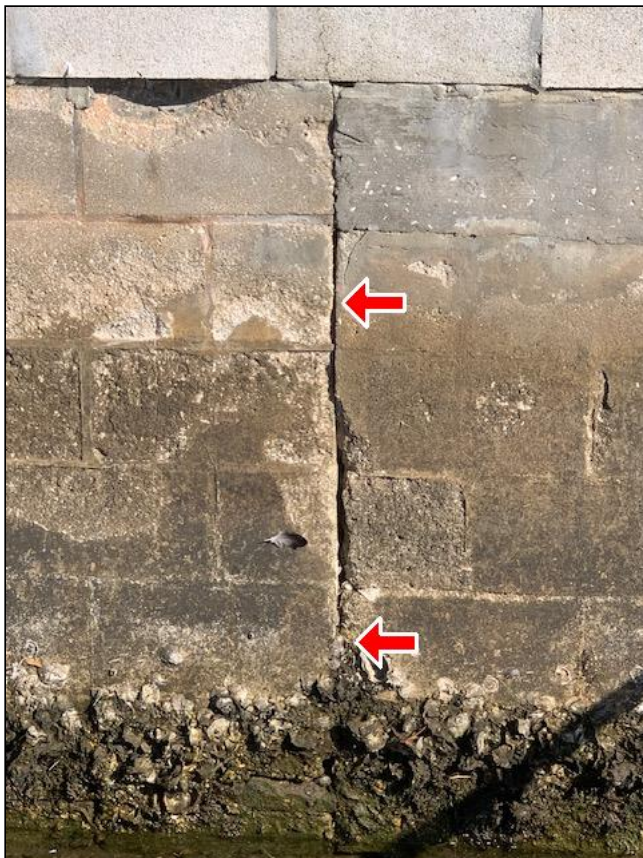
Two vertical cracks were observed at the length of wall. Have these evaluated and repaired as needed.

10.2 Item 1(Picture) cold joint crack

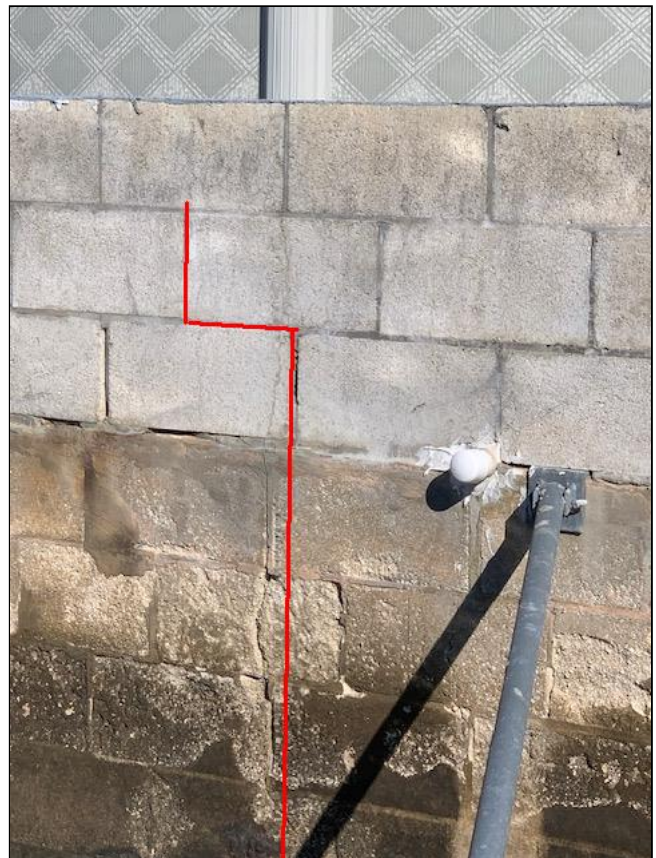
10.2 Item 2(Picture) stair step crack leading to vertical wall crack

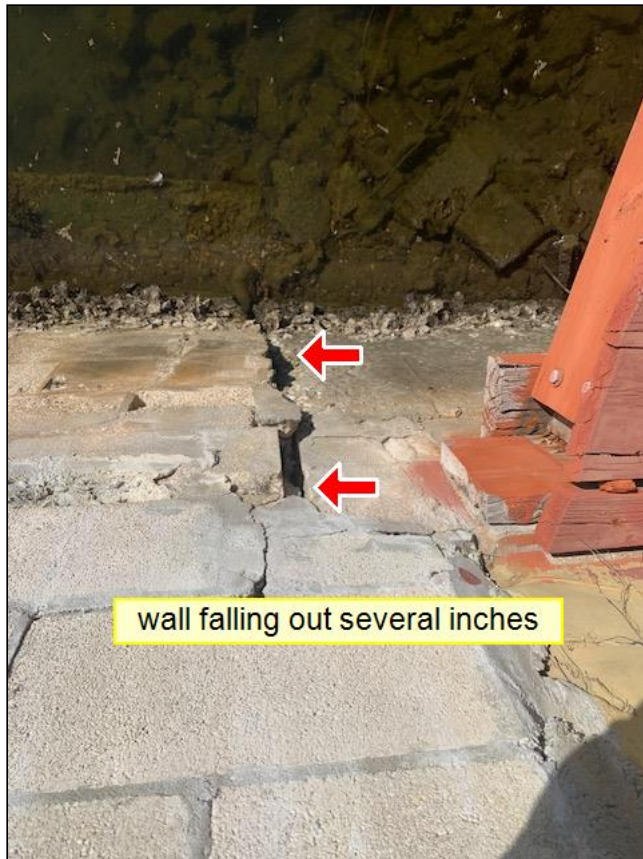
10.2 Item 3(Picture) view at western corner

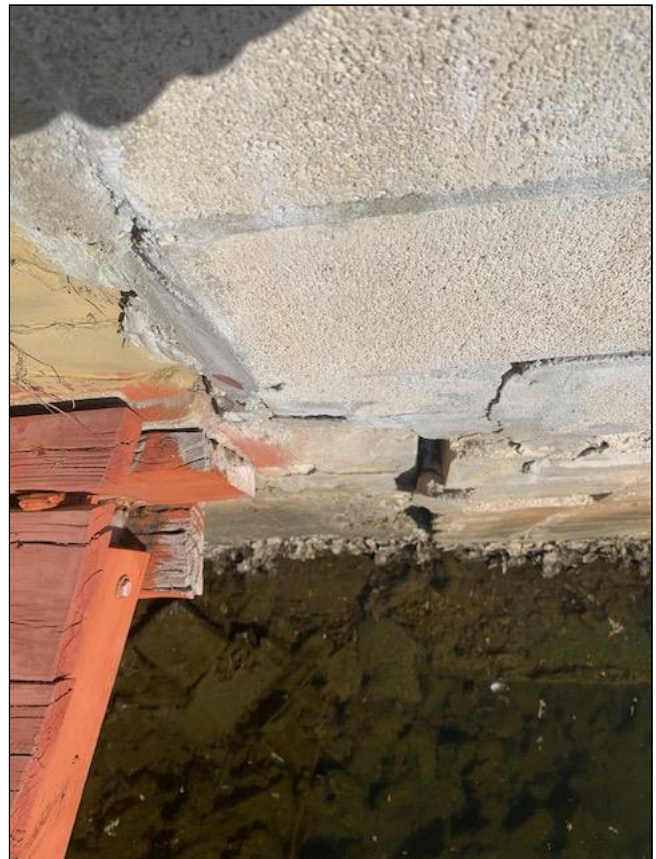
10.2 Item 4(Picture) alt, view

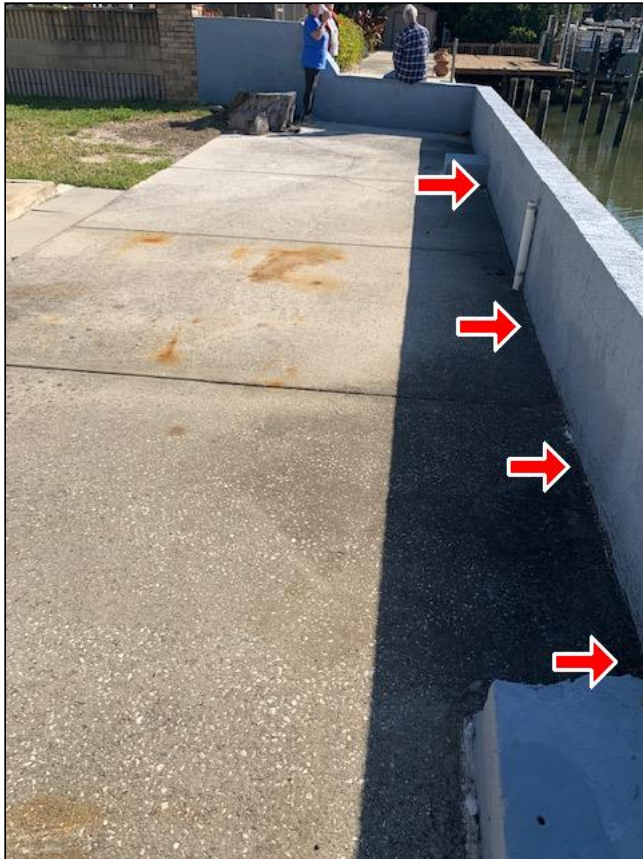
five of the nine drains have been capped off. Have these drains opened so water to get off the cap instead of going behind the wall causing hydrostatic pressure.

10.3 Item 1(Picture) drain holes blocked

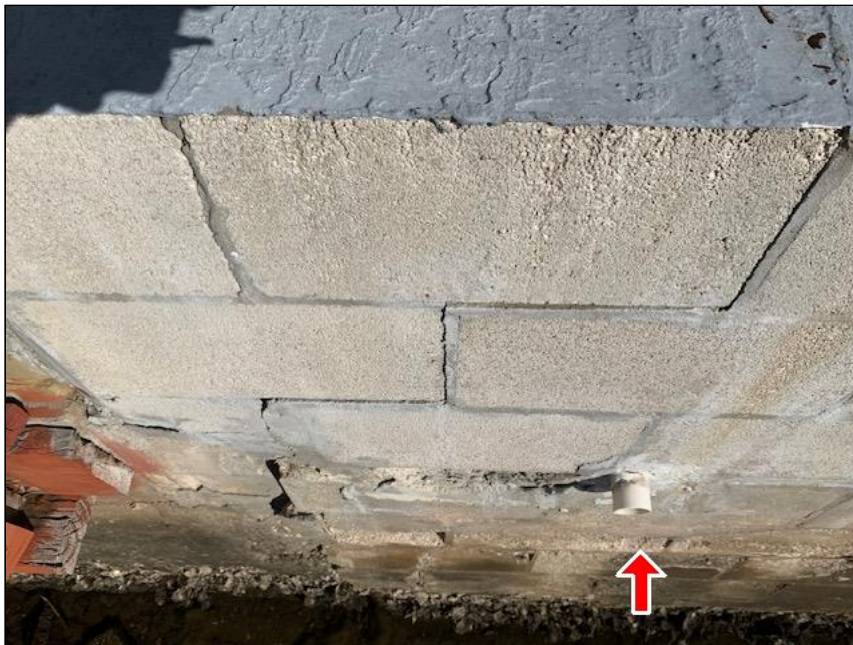
10.3 Item 2(Picture) this drain open

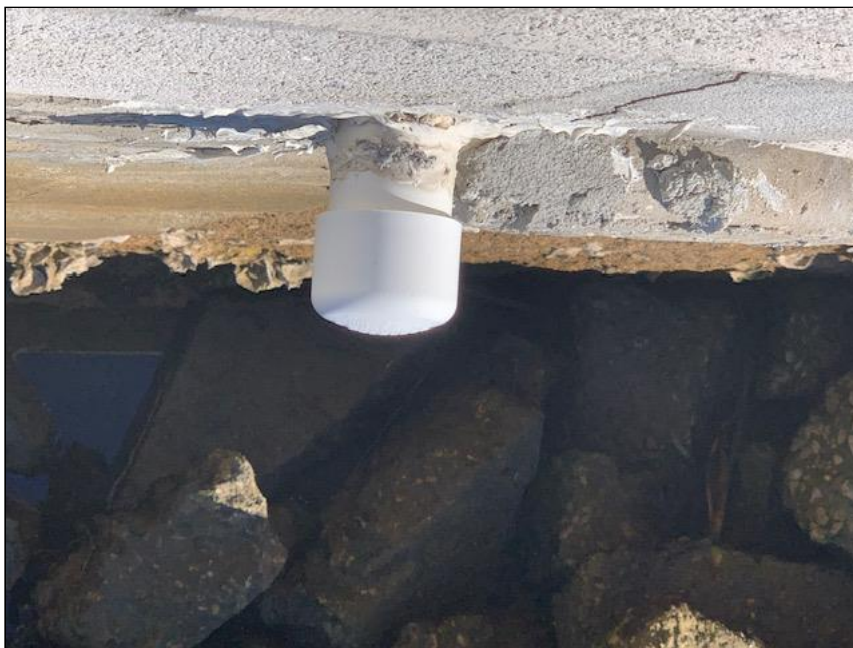
10.3 Item 4(Picture) capped off
