General Summary

Hudson FL 34667

10. Seawall Inspection

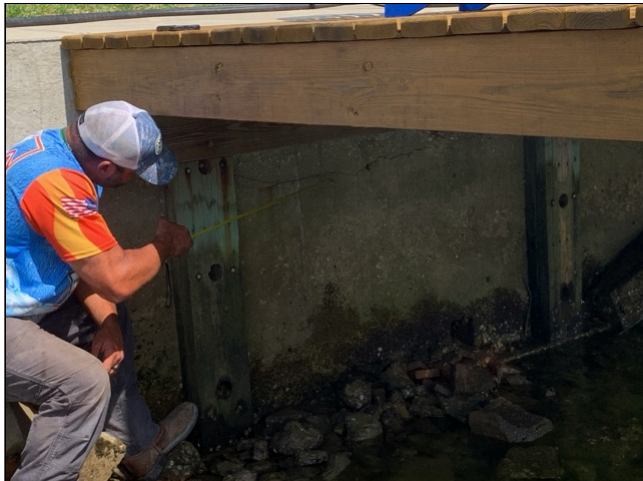
I observed one horizontal crack underneath the deck extending out three feet. This can be repaired with an epoxy to prolong its life.

10.2 Item 1(Picture) location of horizontal crack

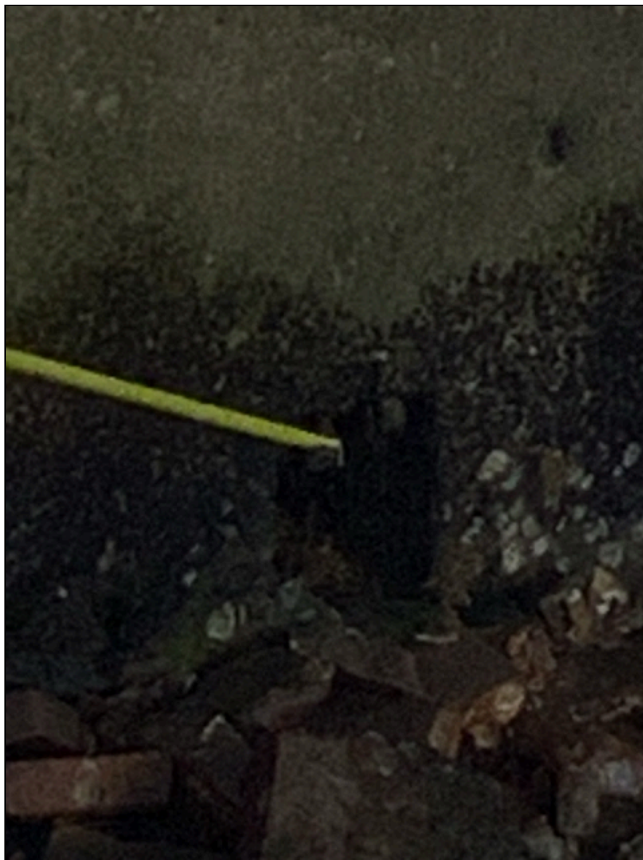
On this sea wall behind piled up rip rap we were able to find open weep holes consisting of CMU block. These open voids which are every 8ft allow silt sand and dirt behind the wall to exit the area leading to voids. The installation of rip rap is designed to slow this process. These voids commonly show as depressions in the yard and lead to cap and wall failure. We recommend these voids be closed off with concrete abutments and properly designed PVC drains installed.

10.3 Item 1(Picture) view of weep drains

Cost Estimates: The new PVC drains should be installed ever 8ft and cost approximately \$300/drain

The abutments that close off the existing voids are approximately \$400-\$500/FT

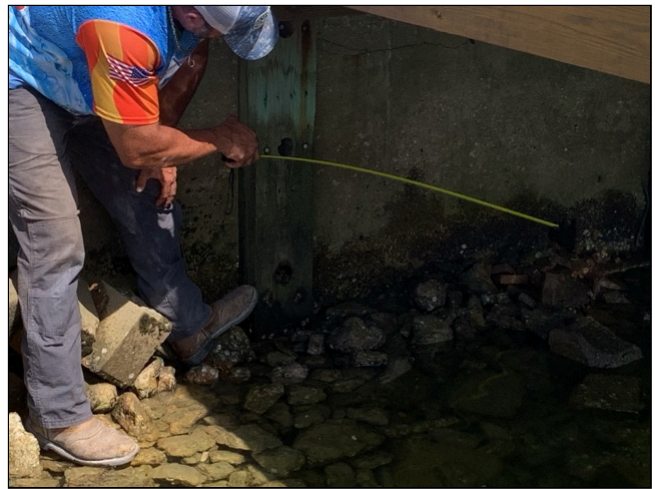
10.3 Item 2(Picture) view of weep drains

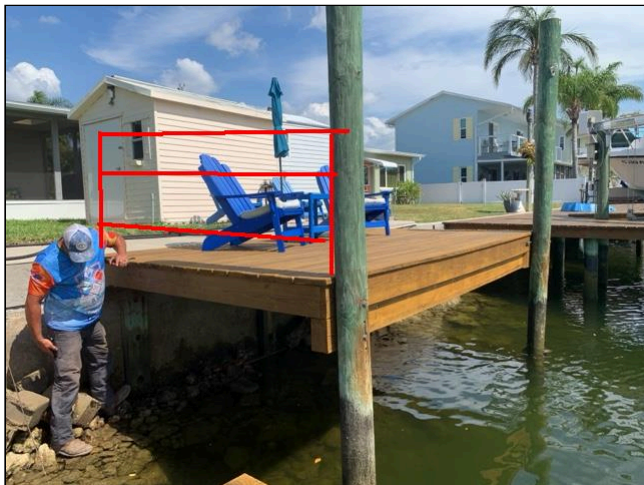
11.1 Item 1(Picture) no handrails present

You may consider adding handrails to the deck for the safety of small children and pets. At a minimum handrails on the sides prevent someone from falling onto the rocks below.

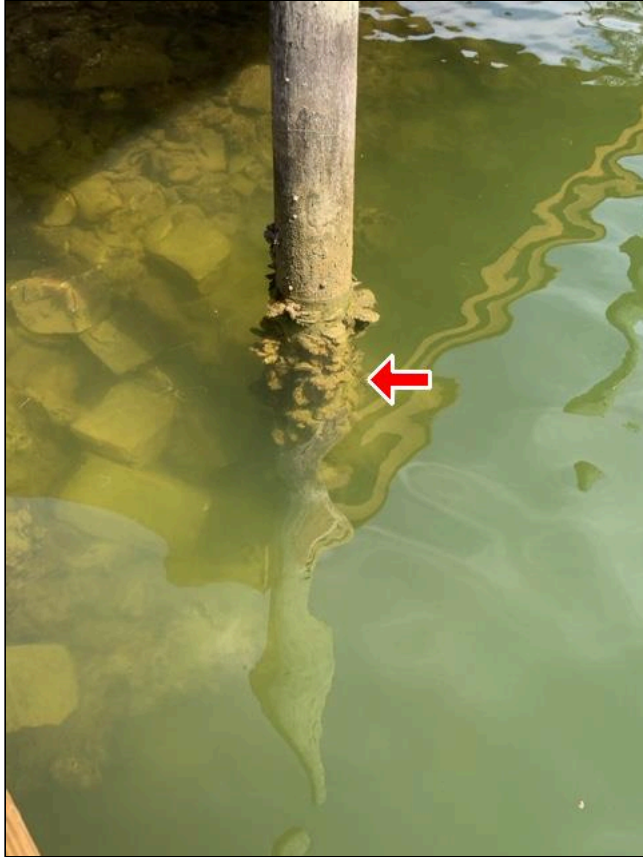
11.2 Item 1(Picture) oysters contain worms and insects

Its recommend that pilings be wrapped with a plastic sleeve to prevent worms from damaging the poles.

Cost: Approximately \$400/pole
