## General Summary

### 11. Docks and Lifts

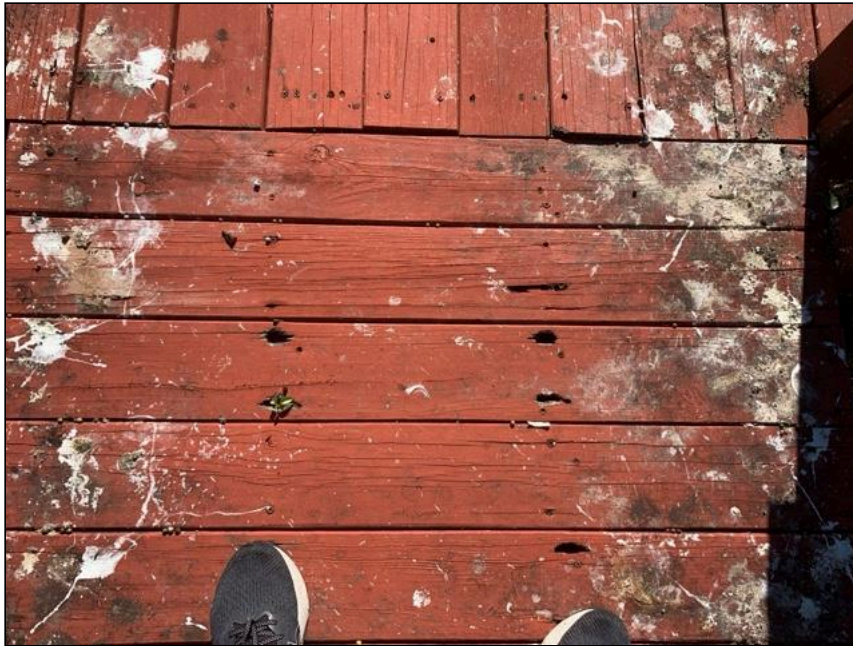
The decking material used is 5/4 board not true dimensional lumber which would be 1.5" in depth. At this time most of the boards are rotted or has loose fasteners and should be replaced with new material.

11.0 Item 1(Picture) holes in boards

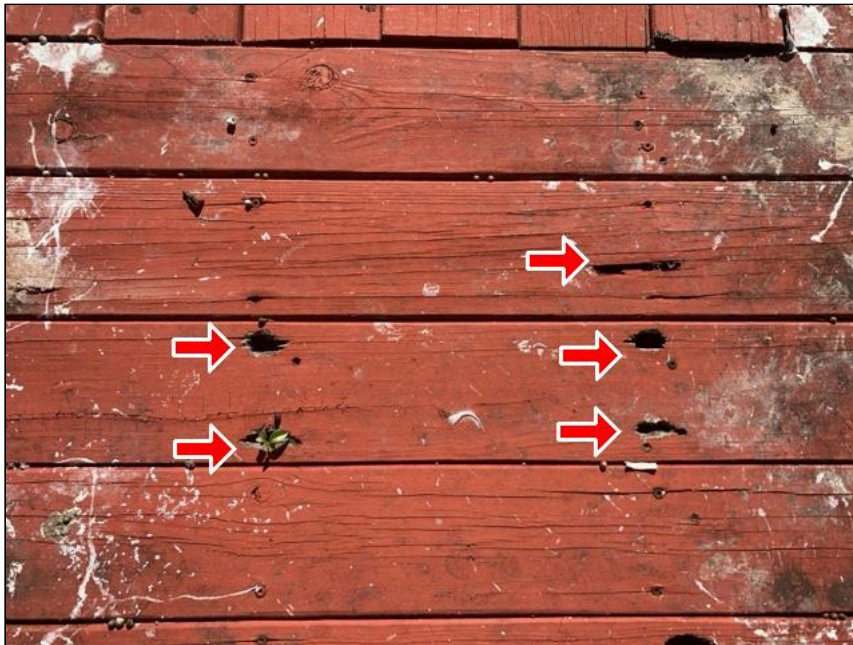
11.0 Item 2(Picture) large holes in boards where water entered fasteners

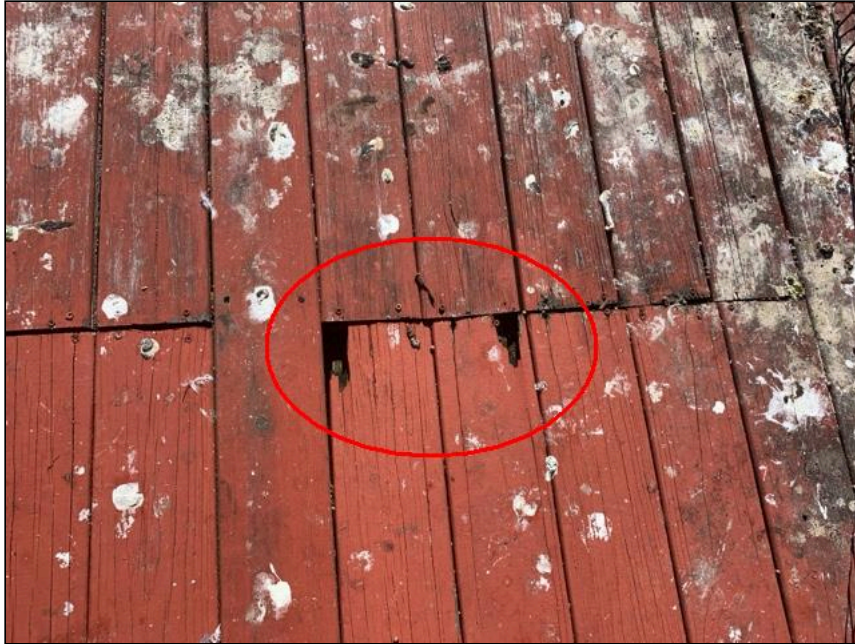
11.0 Item 3(Picture) rotted boards

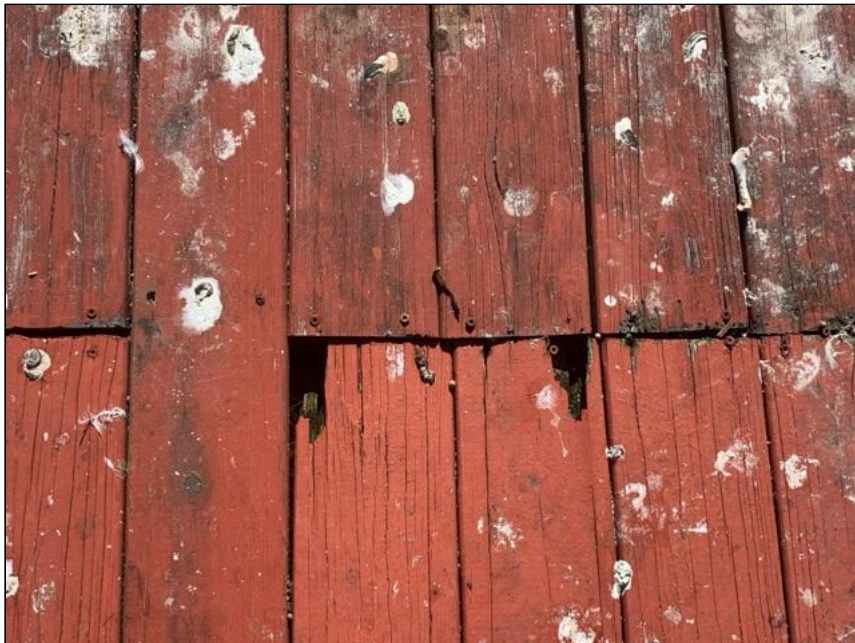
11.0 Item 4(Picture) close up

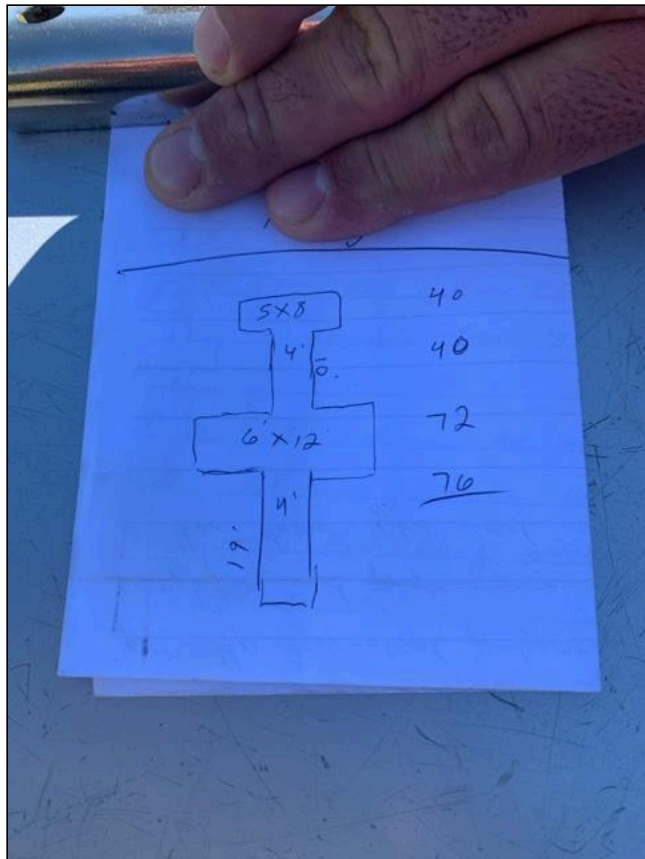
11.0 Item 5(Picture) dimensions of existing deck

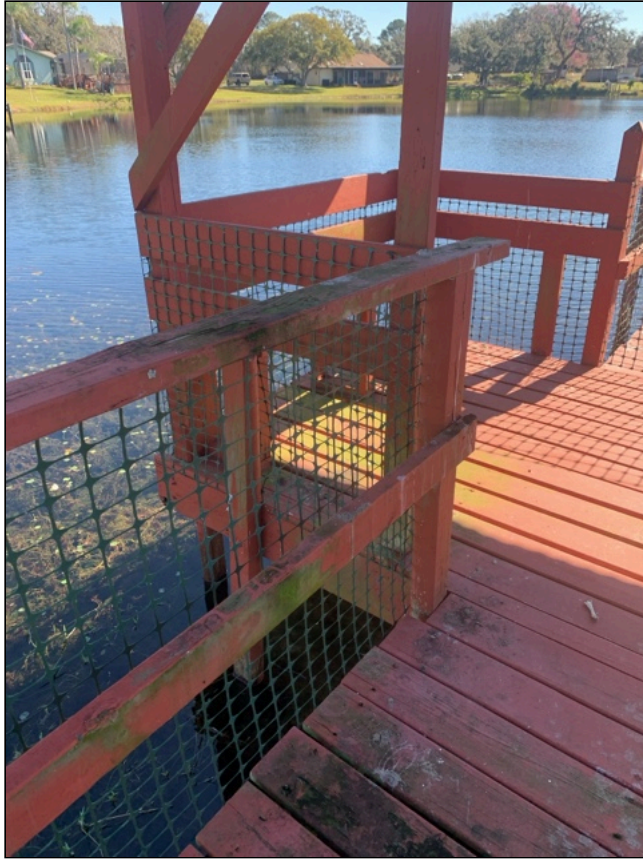
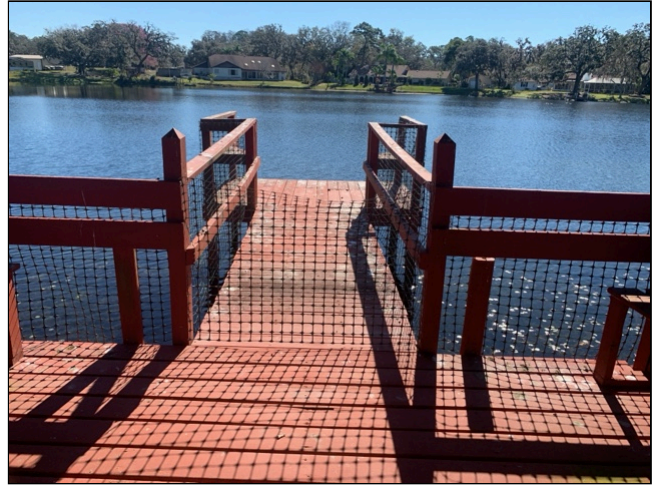
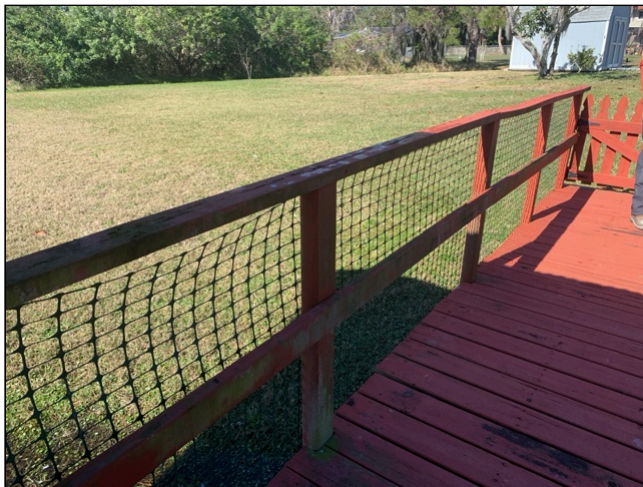
The plastic netted railing would not meet current standards or code for safety. Vertical pickets need to be installed of dimensional lumber with a spacing no greater than 4".

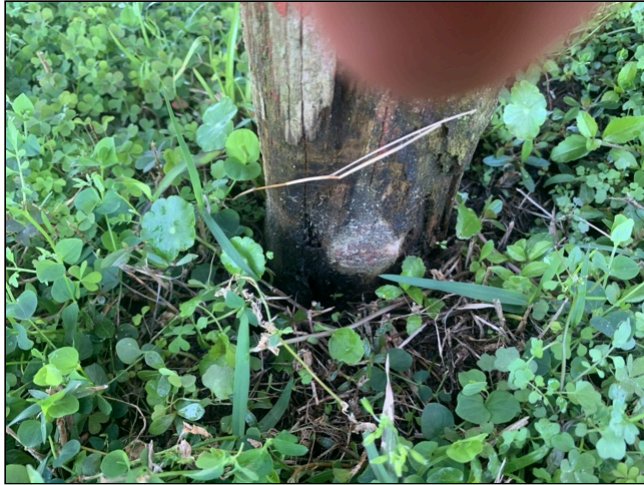
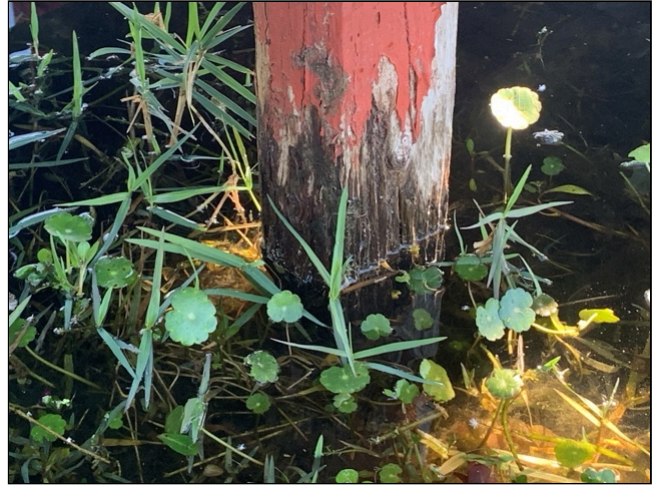
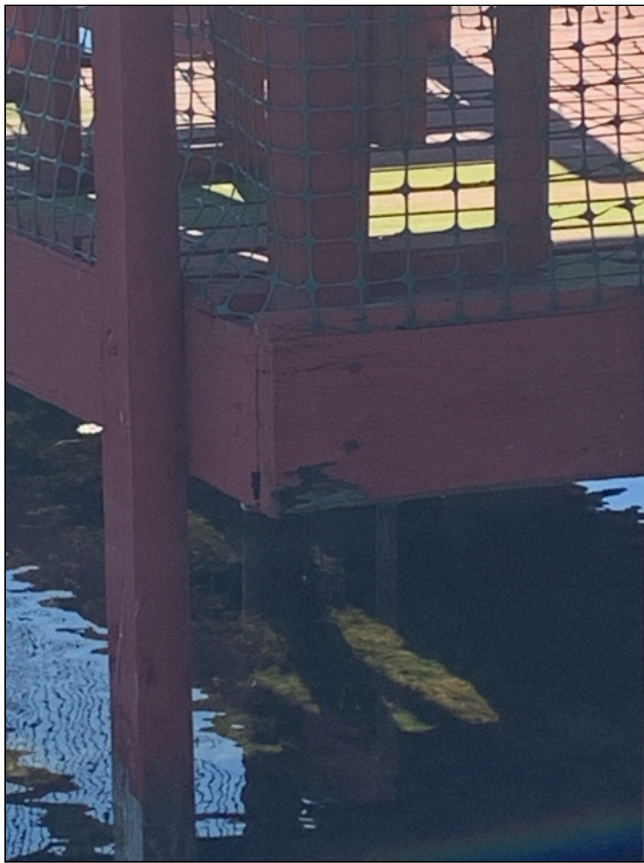
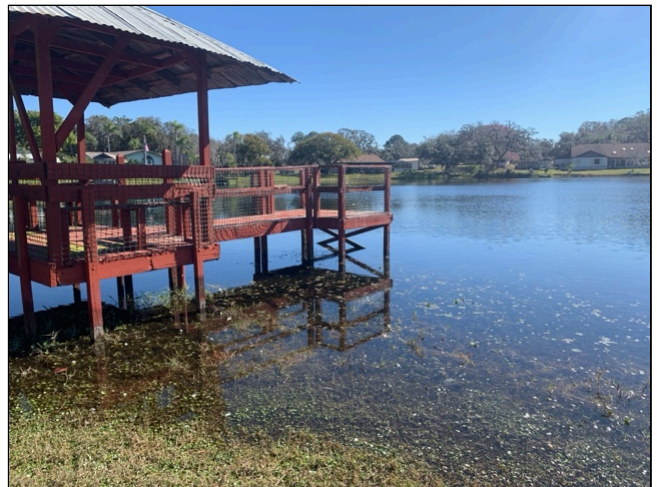
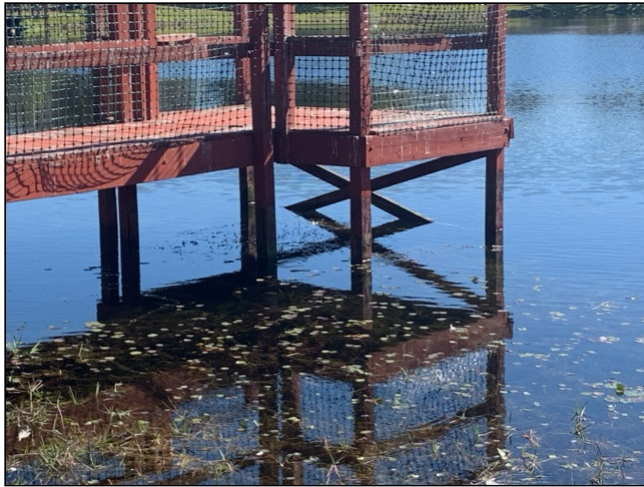
(1) The load bearing post are actually landscape timber designed for light residential retaining wall use. This material is not considered to be rated for water contact. When this structure is replaced consider using 6x6 P/T (pressure treated) post or Pilings P/T.

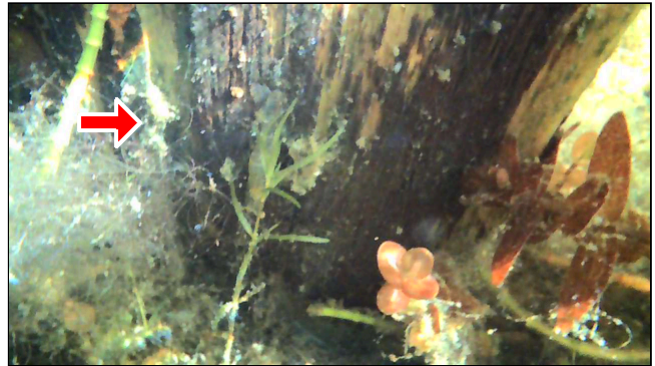
11.2 Item 6(Picture) view of timber with underwater scope

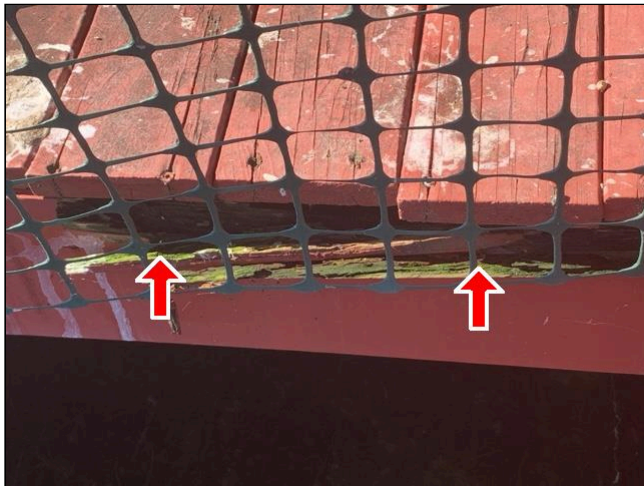
(2) The 4Ft. walkway extension out to the furthest platform shows rotted floor joist and will need replacing with new dimensional lumber.

11.2 Item 7(Picture) joist rotted

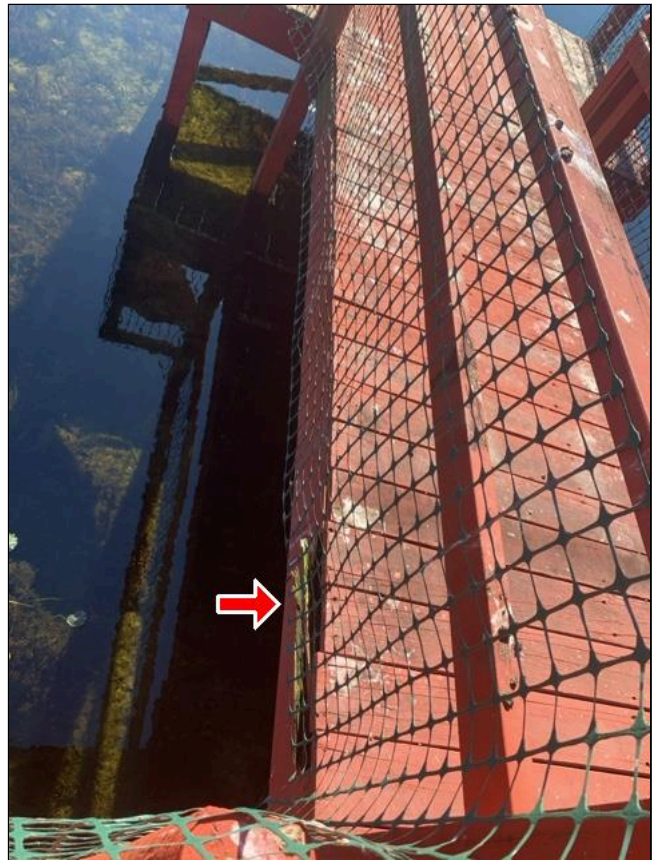
11.2 Item 8(Picture) perspective location

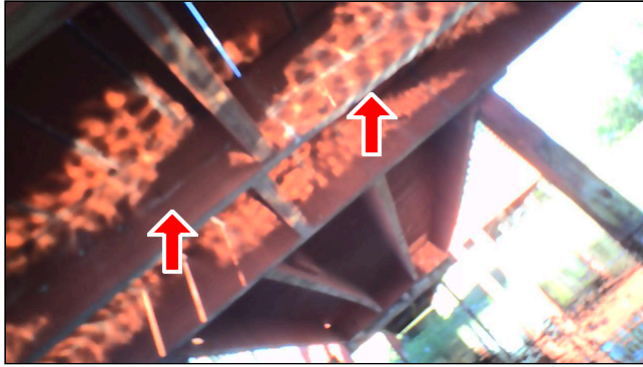
11.2 Item 9(Picture) rot underside of walkway platform

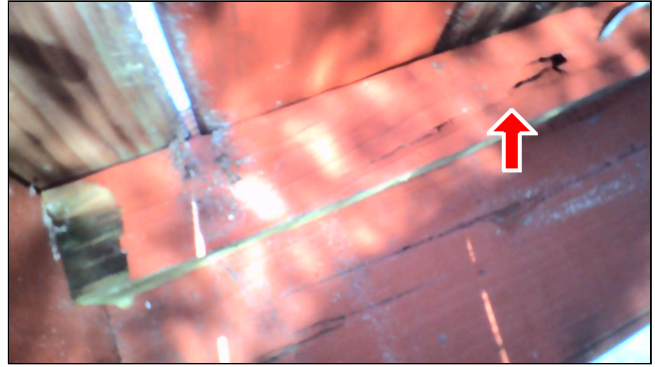
11.2 Item 10(Picture) rotted framing members

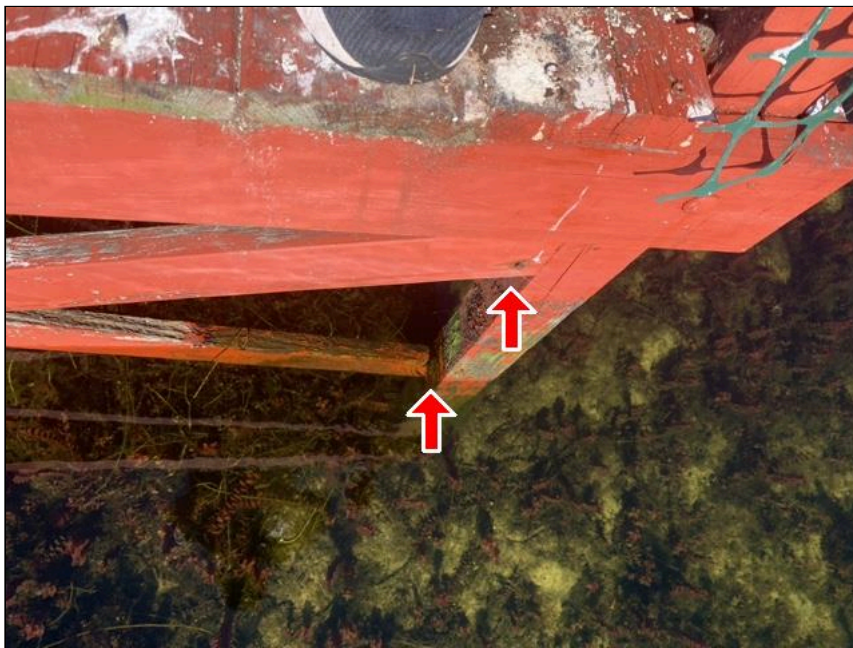
(3) The cross members on outer section of platform are loose allowing the whole assembly to rack back and forth when weight is shifted. Have this secured as needed till extensive work or replacement can be completed.

11.2 Item 11(Picture) not secured with fasteners here

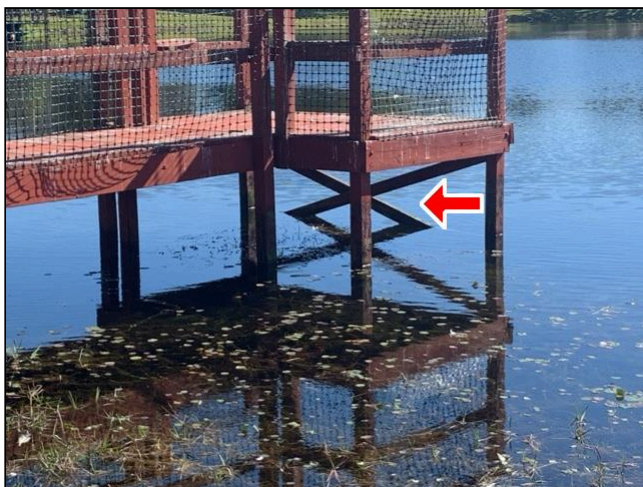
11.2 Item 12(Picture) loose cross members

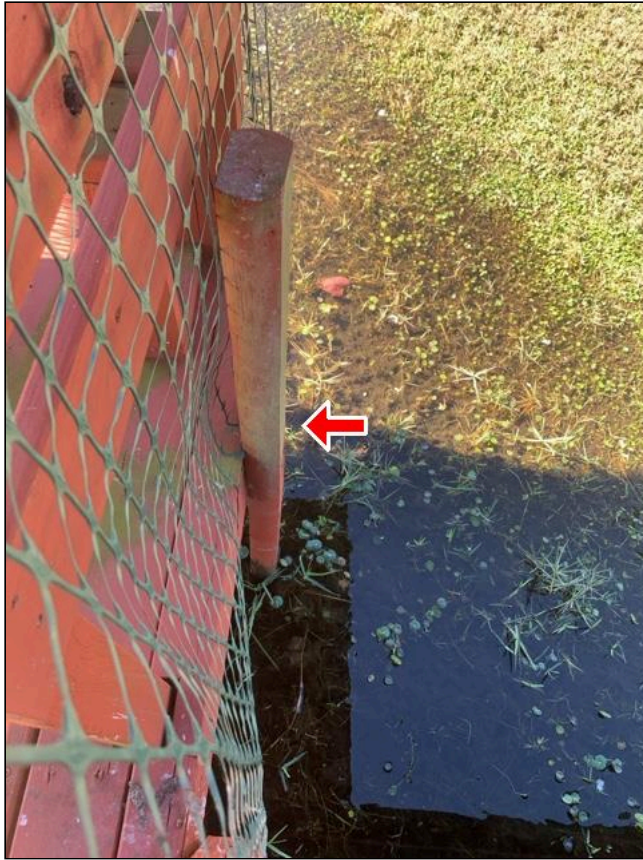
11.2 Item 13(Picture)

(4) The load bearing post for the gazebo area is tweaked from the amount of weight on this section of

structure. This post should be a 6x6 minimum as its holding a roof and deck load.

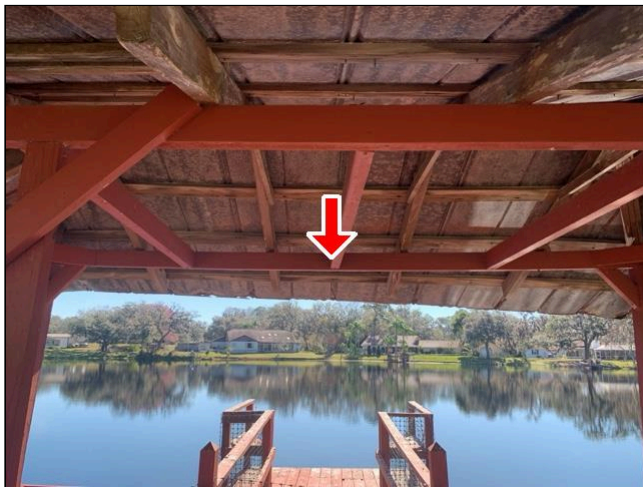
(5) The outer 2 x 4 that holds up the roof rafters is deflecting in the middle several inches. Additional post could be added, however lifting the roof would be the end result which would cause issues with the roofing material. It would be best to add temporary supports remove the deflecting lumber and replace with new material.

11.2 Item 14(Picture) deflecting down 2"

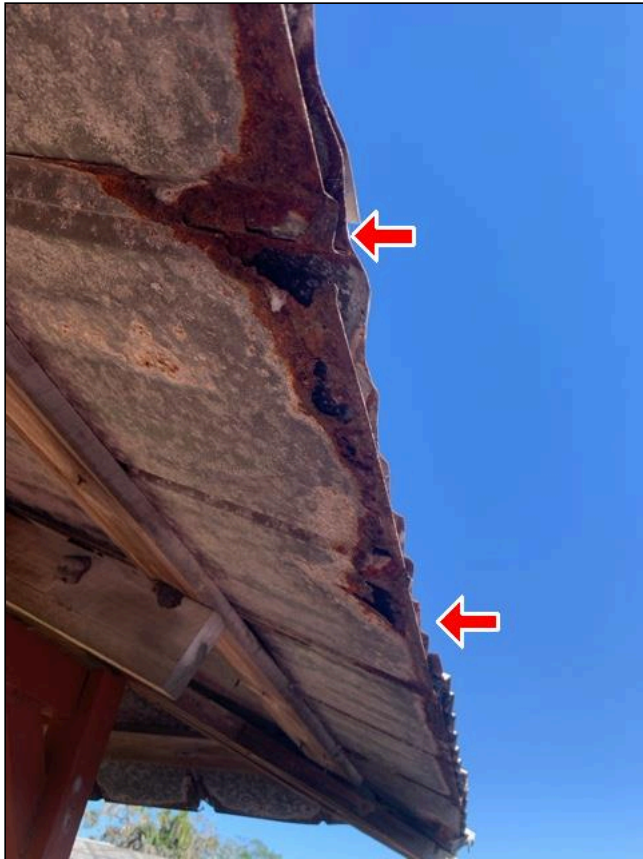
The metal galvanized roofing material is rotted and missing at the outer edges and the ridge line. The roofing material should be replaced.

11.4 Item 1(Picture) rot in outer edge

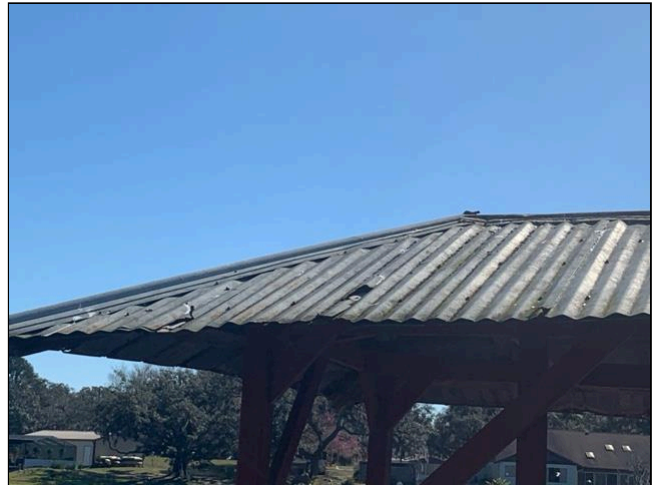
11.4 Item 2(Picture) broad view

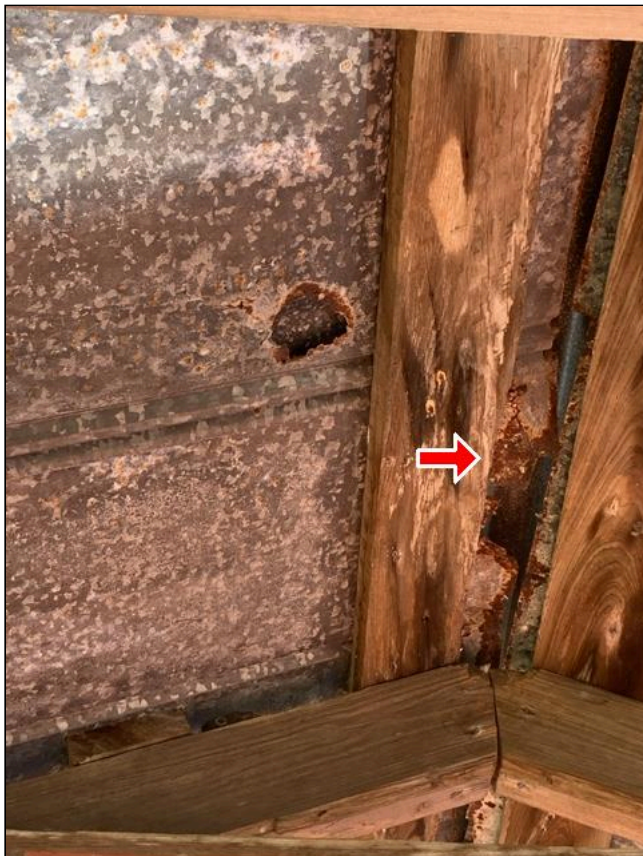
11.4 Item 3(Picture) holes at ridge
